SERVICE BULLETIN

EOS engine

date of release	.Dec. 2018	issue 1, #1218_1_m
for engine type / applicability	engines EOS 150 (ICI)	
status	mandatory	optional

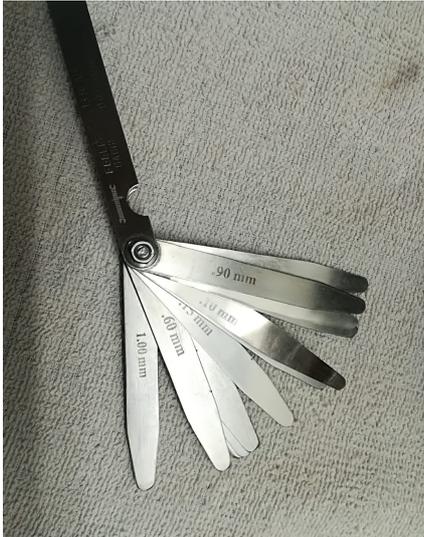
feeler gauge tool to correctly measure ring gap

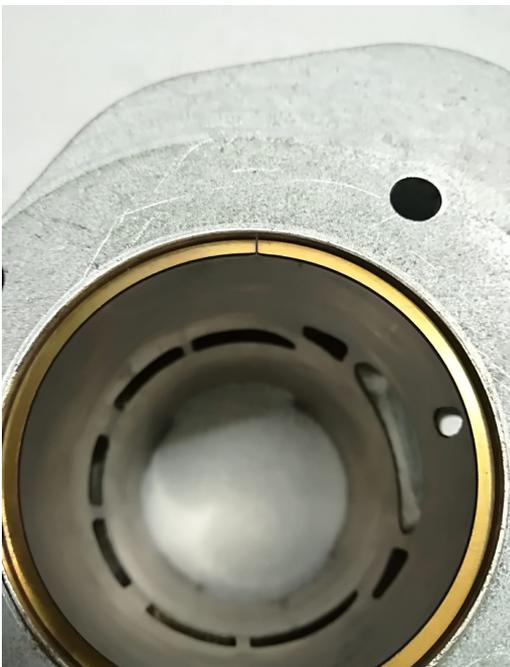
place ring into the bore of the cylinder as shown

Dismount cylinder head and cylinder. Leave piston on crankshaft. Take off one upper piston ring and place into the cylinder as shown. Measure gap. Same with second piston ring. If in accordance to given measurement then place rings back to piston and reassemble engine.

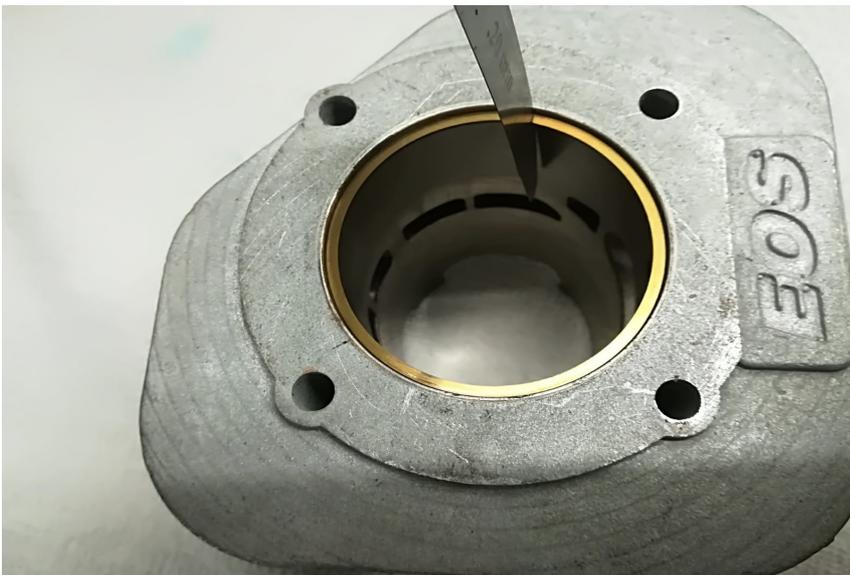
measure gap

Correct gap measurement; 0,22 - 0,30mm

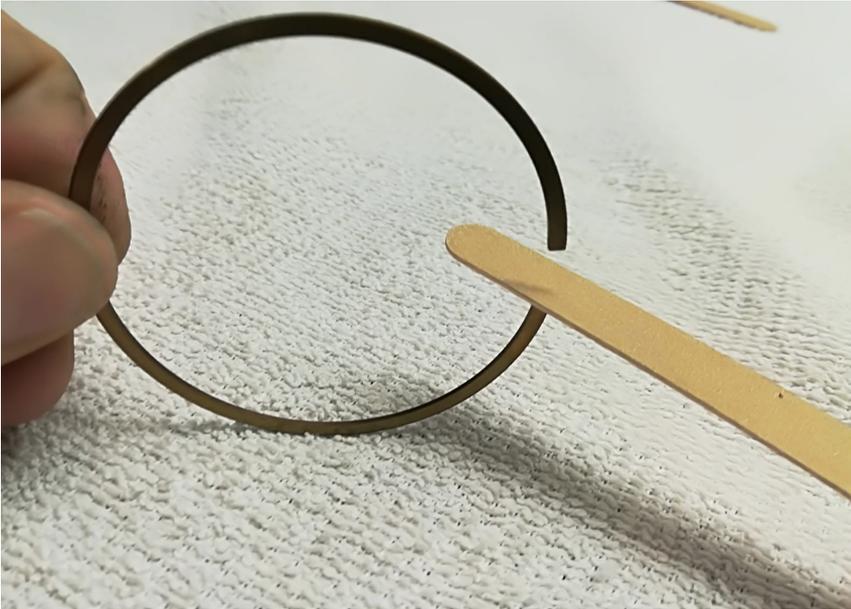
if necessary correct
gap with nail file

If measurement of gap smaller than given measurement then correct gap with nail file.
