SERVICE BULLETIN

EOS engine

date of release	.Nov. 2019	issue 2, #1119_2_m
for engine type / applicability	engines EOS 150 (ICI)	
status	mandatory	optional

Advice for a mandatory drive wheel bracket change.

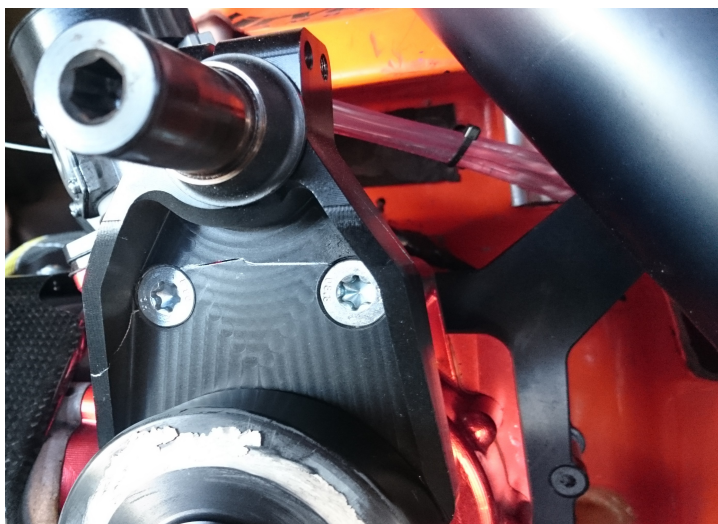
We refer to the already in Nov. 2018 released mandatory Service Bulletin # 1118_1_m where we have advised for a pre-flight check and inspection of the subject mount bracket for possible cracks and damage. Now due to several failures of this mount bracket during engine operations where brackets broke totally we release this second Service Bulletin with the advice for a change to a new type part. The new bracket is changed in design and stronger preventing a new failure.

bracket with clearly visible cracks but not yet totally broken

Before any new engine operation whether on ground or for flight **it is imperative to replace this subject mount bracket by a new part**, whether by type 1 or by type 2 (see next pictures). Even if there are no visible cracks or any kind of damages on the installed bracket the change is necessary for safety reasons!

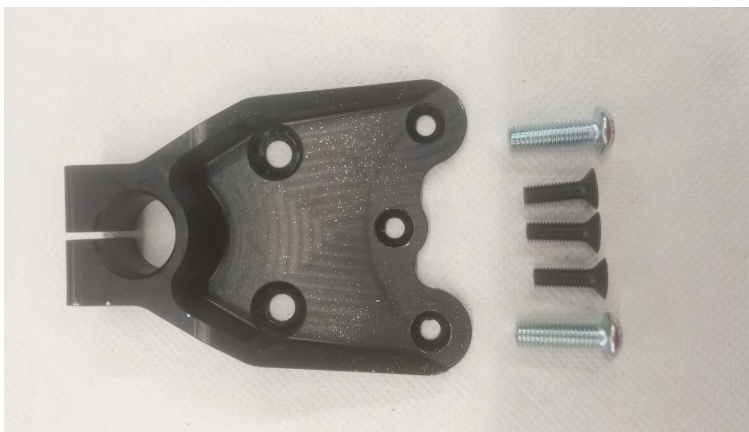
old type bracket
to replace!
