# Oil Separator Modification

Some customers reported minor oil leaks from the engine ventilation system. We investigated the issue and have introduced a technical improvement to fix it.

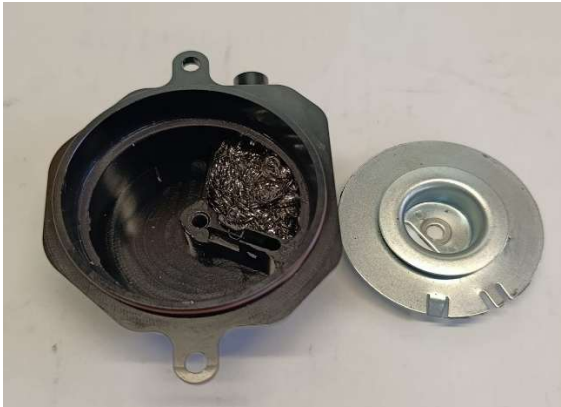
1. Remove the oil separator from the engine
2. Remove the deflector plate

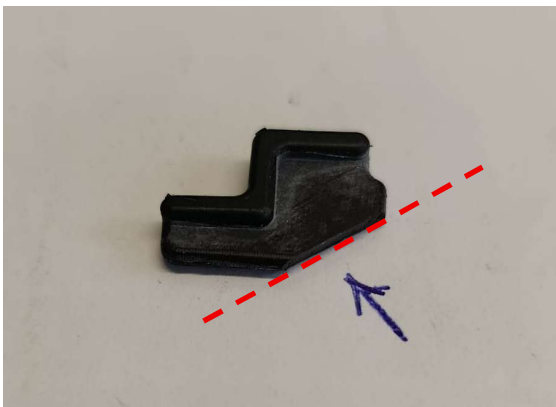
3. Remove the oil seal and trim the edge

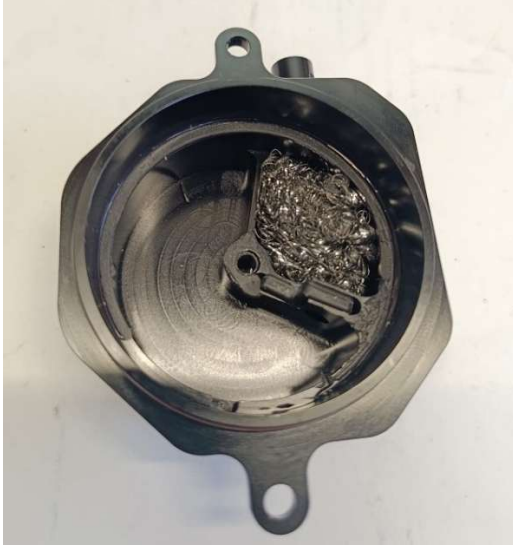
4. Thoroughly clean all parts to remove any oil residue

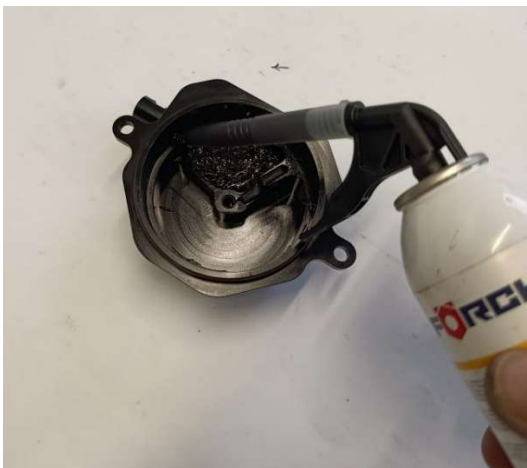
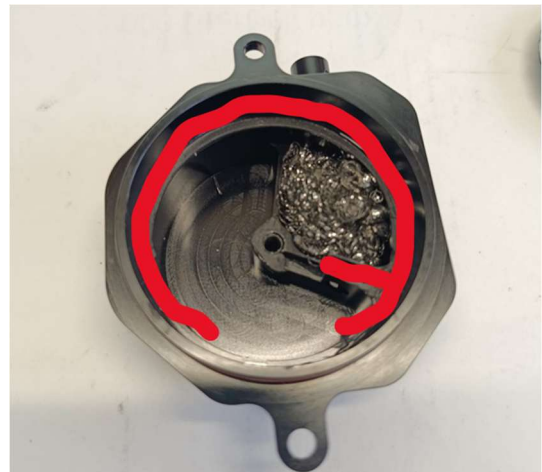
5. Apply liquid engine silicone to seal the deflection plate

By sealing the oil deflector plate inside the oil separator, oil spillage can be stopped. However, please note that if oil enters the labyrinth, a small amount may still exit through the ventilation tube in some cases.

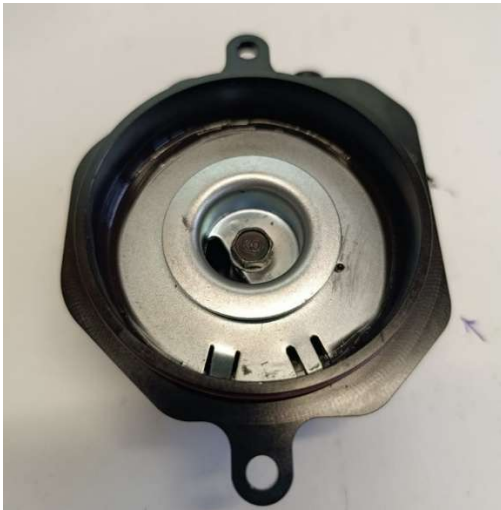
6. Reinstall the oil separator and tighten the M6 screw to 12 Nm
